DEPARTMENT OF AGRICULTURE

**REHABILITATION OF
GENERATOR SHED**

BRGY. TAGUIBO, DA-WAREHOUSE, BUTUAN CITY

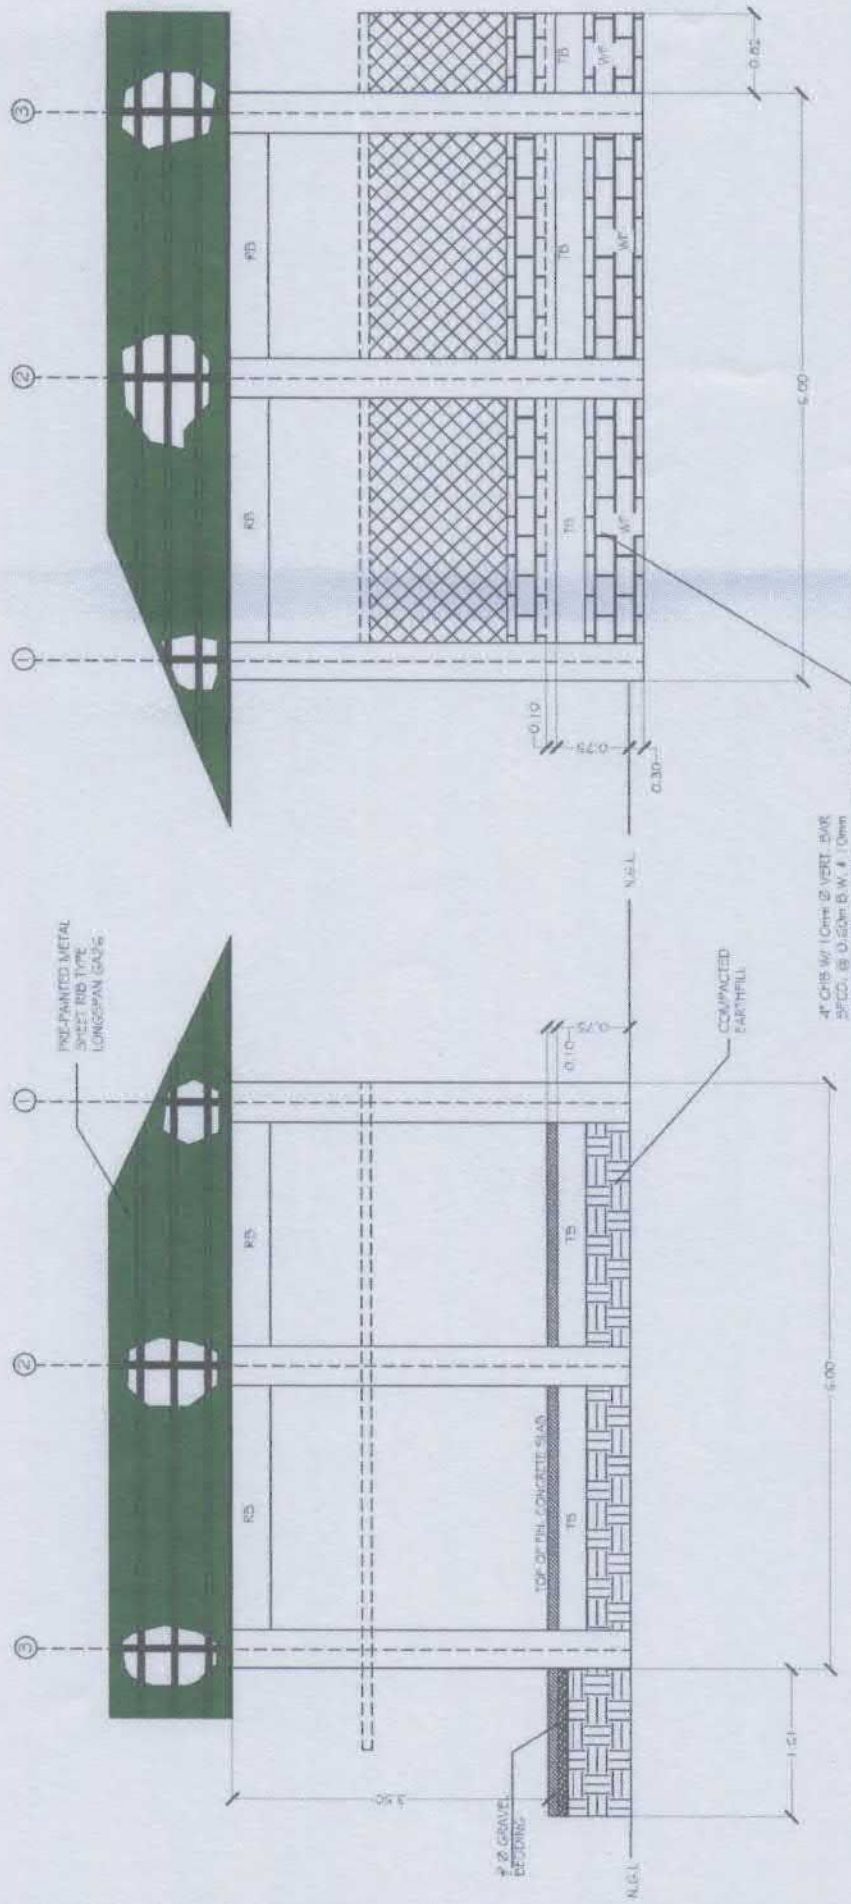
RIGHT ELEVATION
SCALE 1:100 MTS

LEFT ELEVATION
SCALE 1:100 MTS

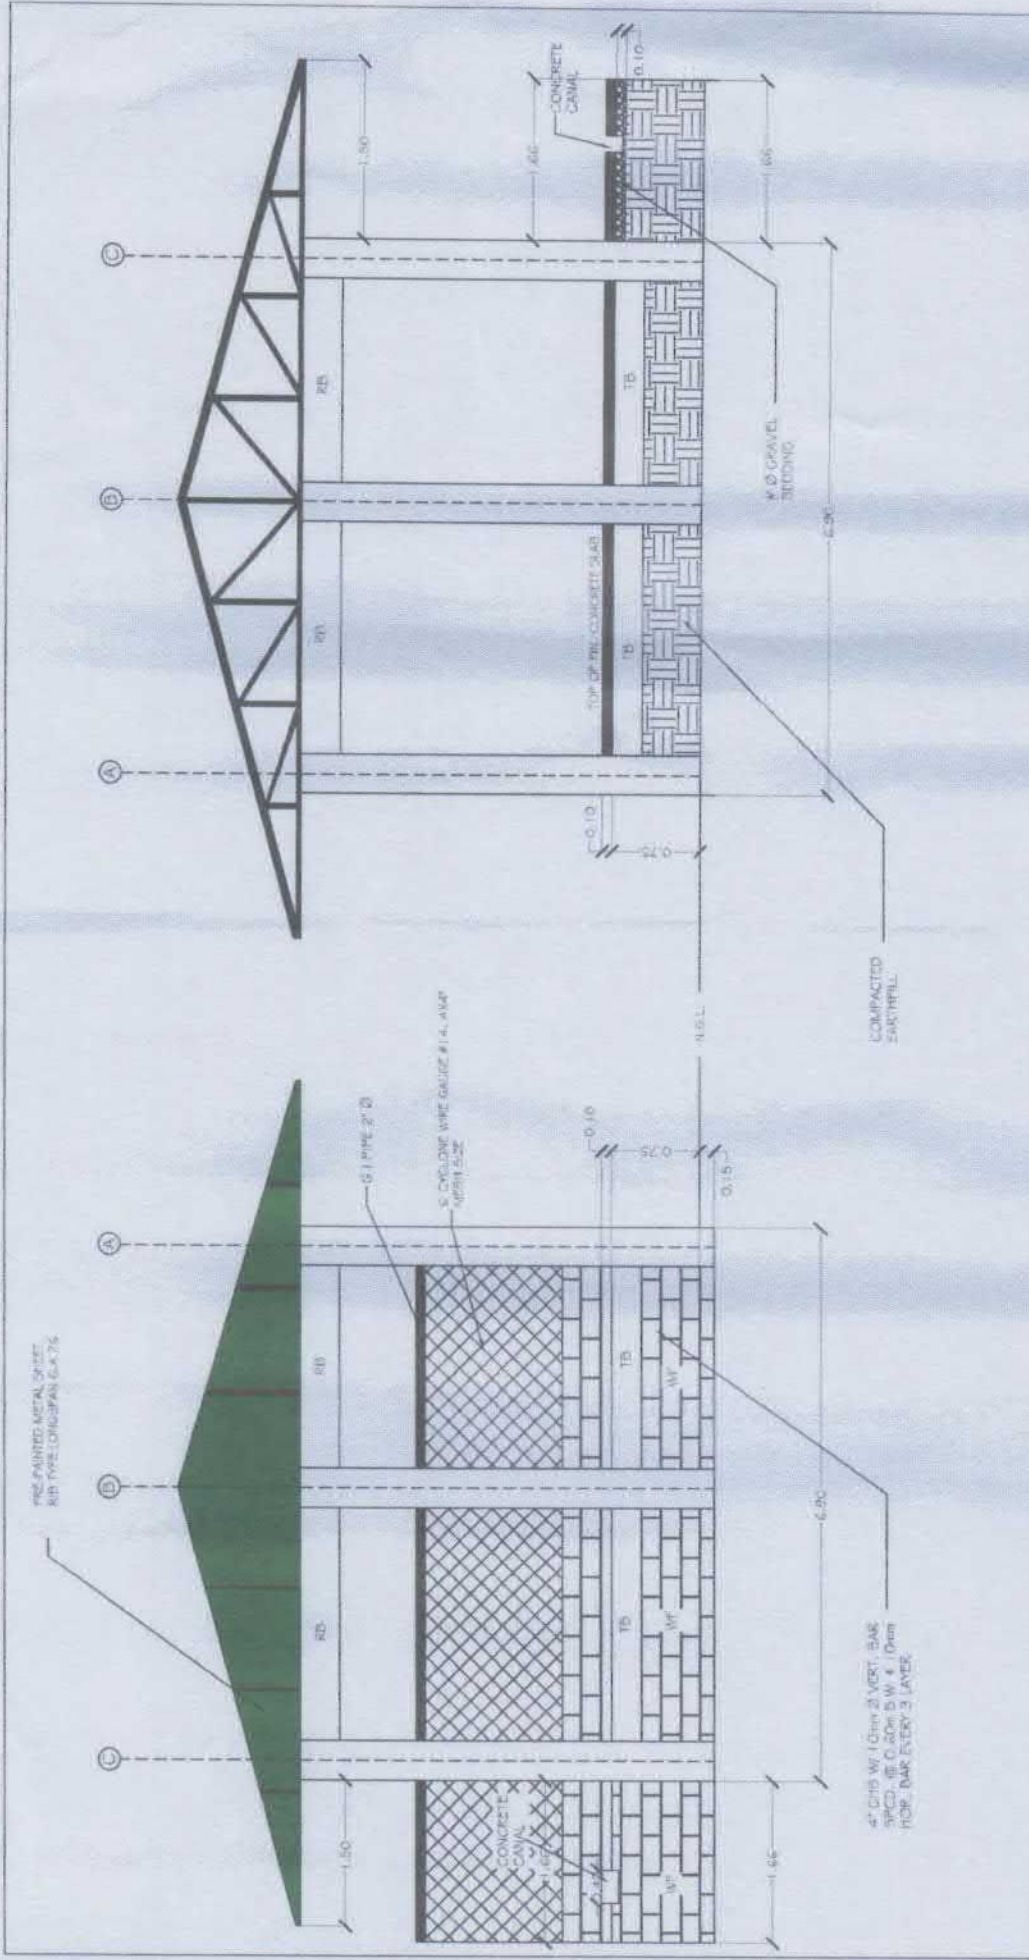
FRONT ELEVATION
SCALE 1:100

REAR ELEVATION
SCALE 1:100

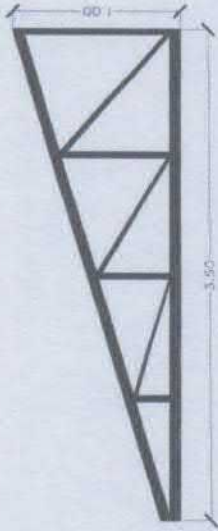
TRUSS - 3 DETAIL
SCALE 1:100 MTS

TRUSS SCHEDULE	
TOP CHORD	1L ANGLE BAR 2"X2"X3mm
BOTTOM CHORD	1L ANGLE BAR 2"X2"X3mm
WEB MEMBERS	1L ANGLE BAR 1.5X1.5"X3mm
GUSSET PLATE	5 mm

NOTE:
INSTALL 5mm THICK GUSSET PLATE EVERY JOINT CONNECTION
